House Energy Efficiency Inspections Project

Final Report

December 2015

A Report to the Department of Industry, Innovation and Science

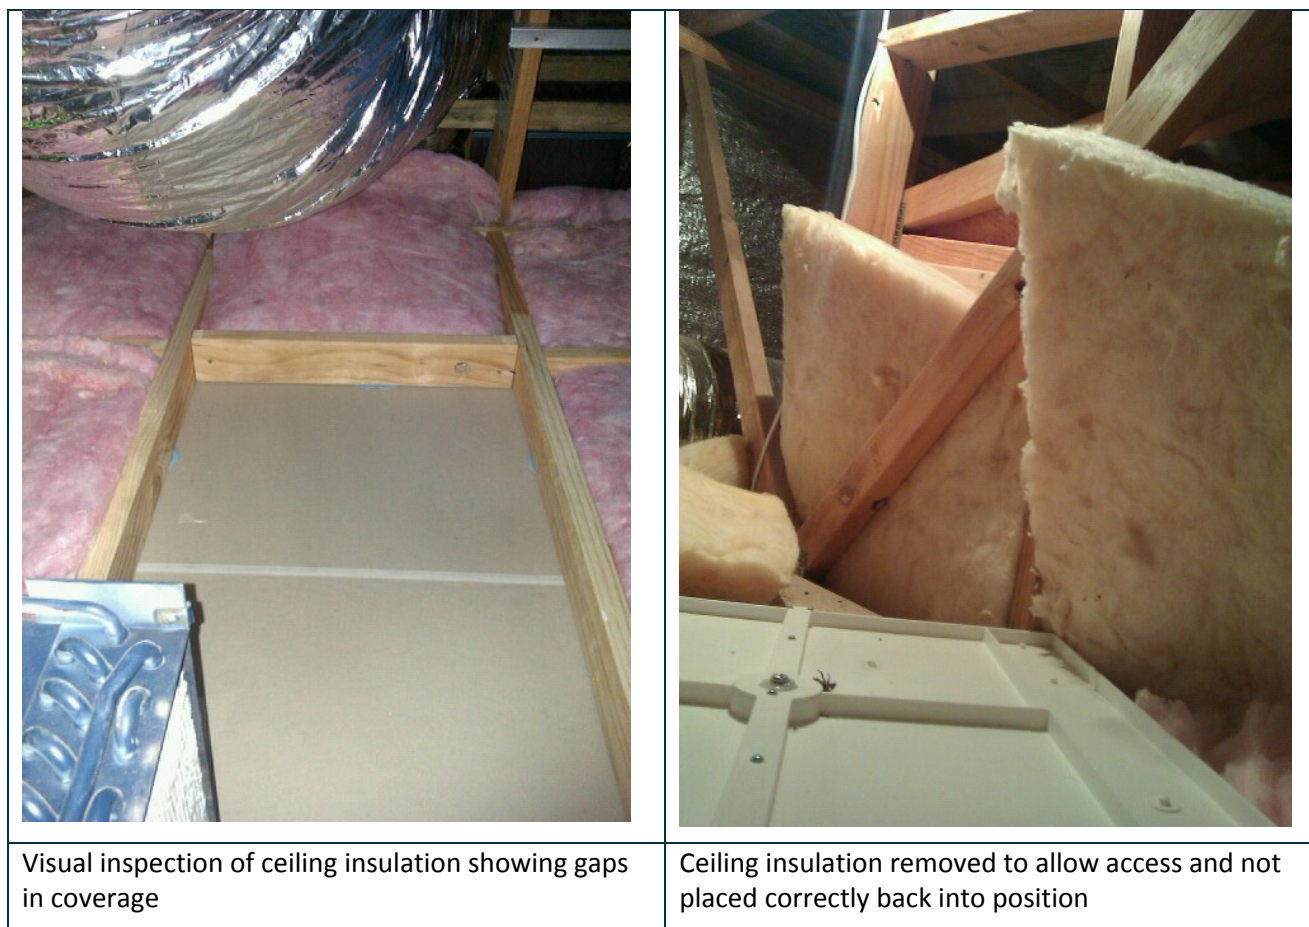
Figure 5 Examples of poorly installed ceiling insulation

Figure 5 shows some examples of ceiling insulation that has been poorly installed or where gaps have been left in the insulation coverage.

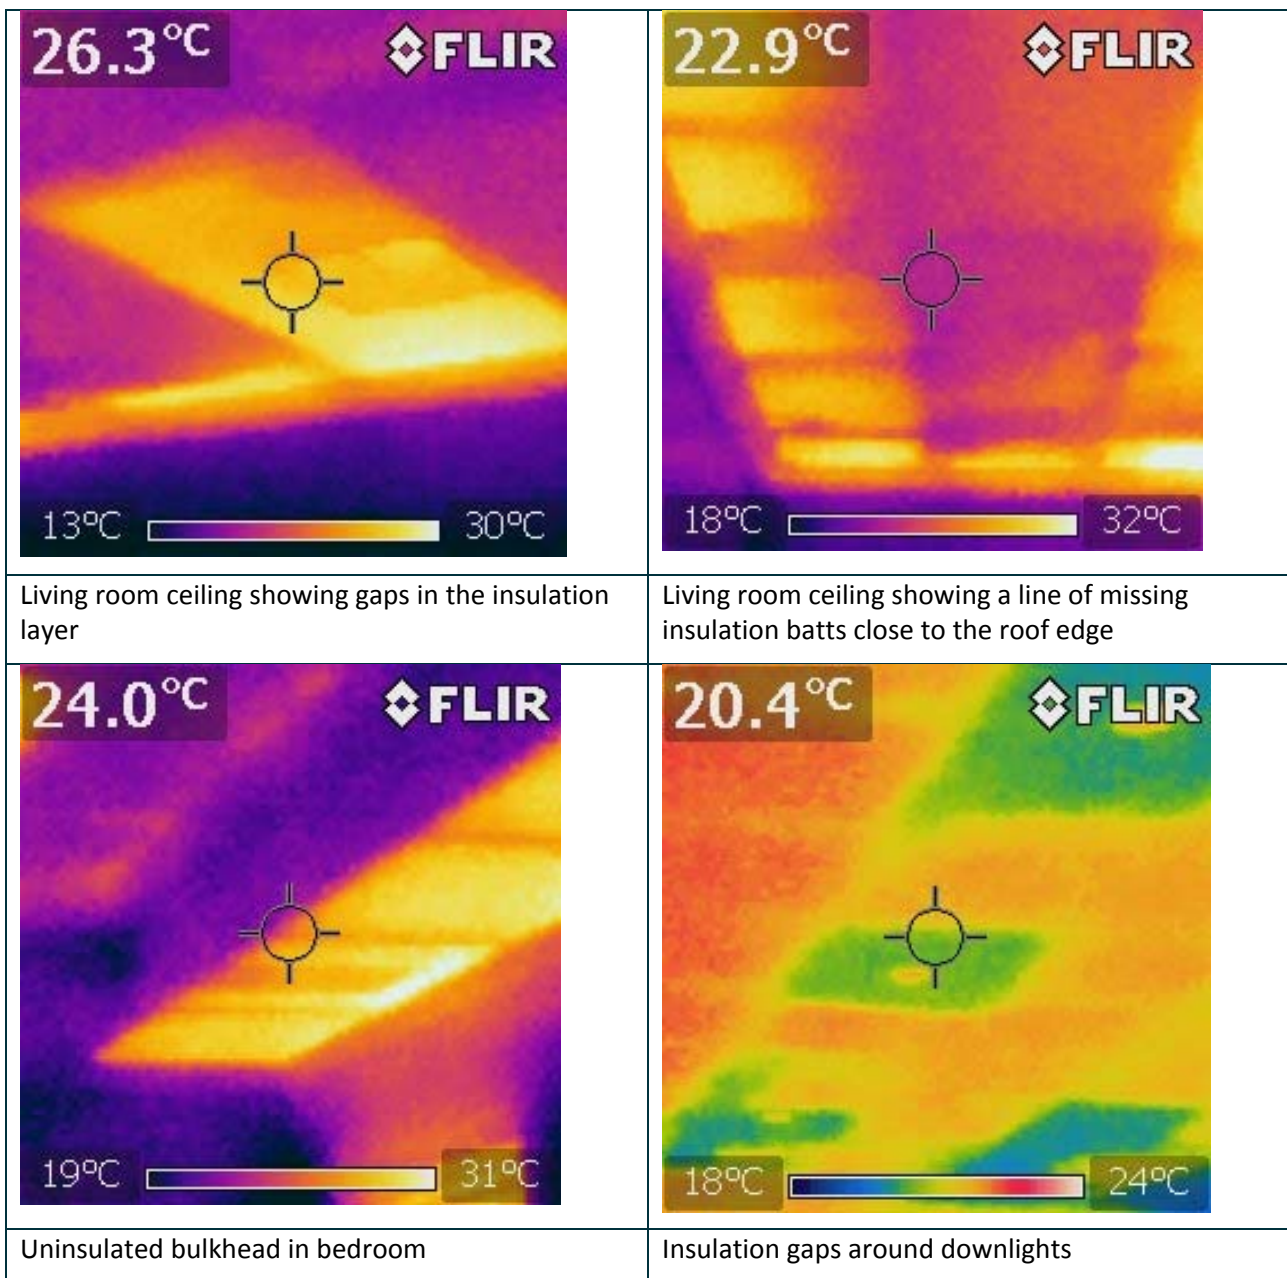
Figure 6 Selected thermal images of ceilings

Thermal imaging of homes can help in identifying whether there is missing insulation or gaps that allow air movement and dampness. The series of thermal images that were taken at each home were uploaded to a secure image sharing website for secure (unique password protected) viewing of the images by each volunteer. Figure 6 is a selection of thermal images from houses that shows the types of insulation gaps that can be identified through thermography. As shown in the colour bars on each image, the darker colours represent surfaces that are at a lower temperature than surfaces with lighter colours. Areas where insulation is missing will show a temperature difference from the surrounding insulated ceiling space. For

example, in hot weather an uninsulated part of a ceiling will show up as being hotter than the insulated parts due to heat transmission from the roof space.

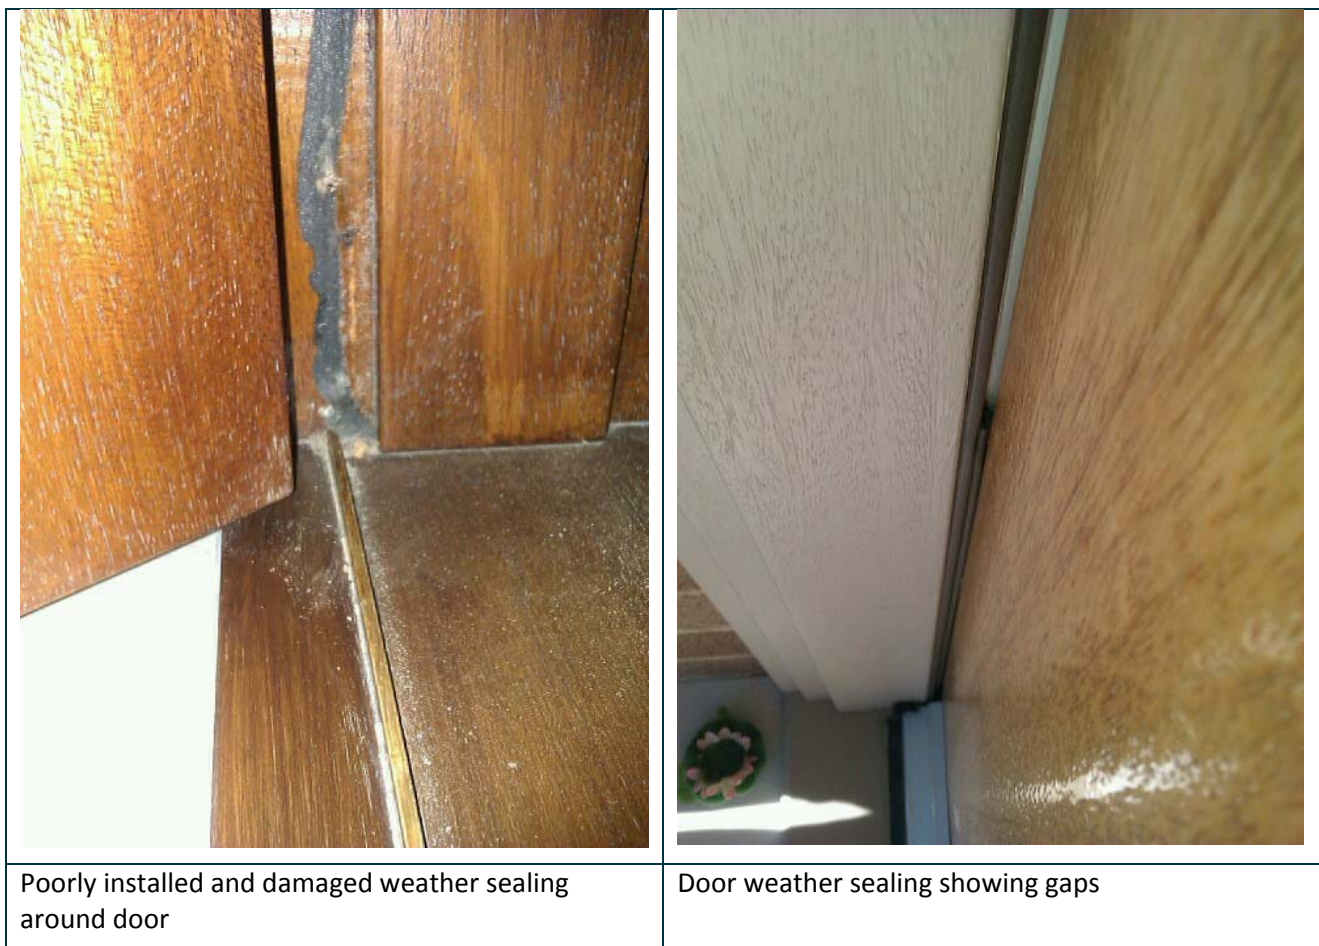
Figure 7 Examples of poor weather sealing on doors

Good quality weather sealing is important to reduce leakage of conditioned air from the house and also to reduce external air and rain entering the house. Weather sealing around doors and windows can help to save up to 25% of heat losses and gains in many climate zones. Regulations require that windows and external doors be weather stripped. It is a fairly simple technique, but can be easily damaged over time with the opening and closing of doors and windows and its effectiveness reduced. Assessors checked for the presence and condition of weather sealing on windows and external doors. Figure 7 shows some examples of weather sealing on doors that has been damaged or poorly installed and has consequently been rated as in poor condition.

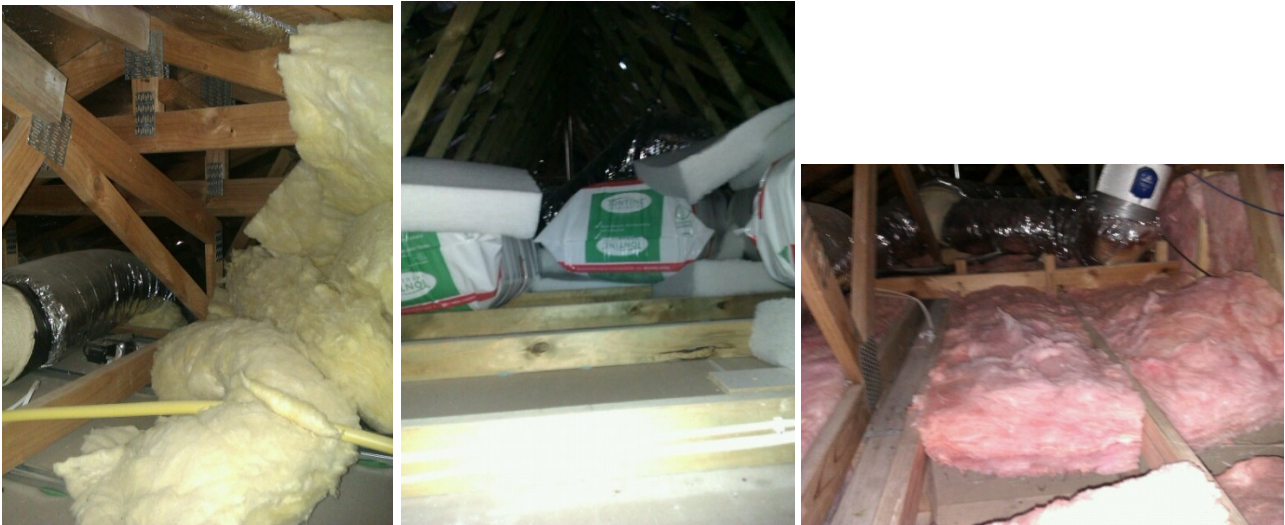
Figure 12 Examples of ceiling insulation rated as poor

Figure 12 shows some examples of houses that had their ceiling insulation rated as poor. The image on the left shows batts moved to place pipework, but not replaced. The centre image has batts still in their packaging and not installed, while the right hand image shows gaps at the end of a batt that have not been filled. Figure 13 shows examples of ceiling insulation rated as average. The image on the left shows larger than required gaps around downlights, the centre image shows damage to the sarking and the image on the right shows inconsistent thickness of the insulation. Finally, Figure 14 shows examples of ceiling insulation as good with both images showing consistent, even and adequate thickness of coverage.

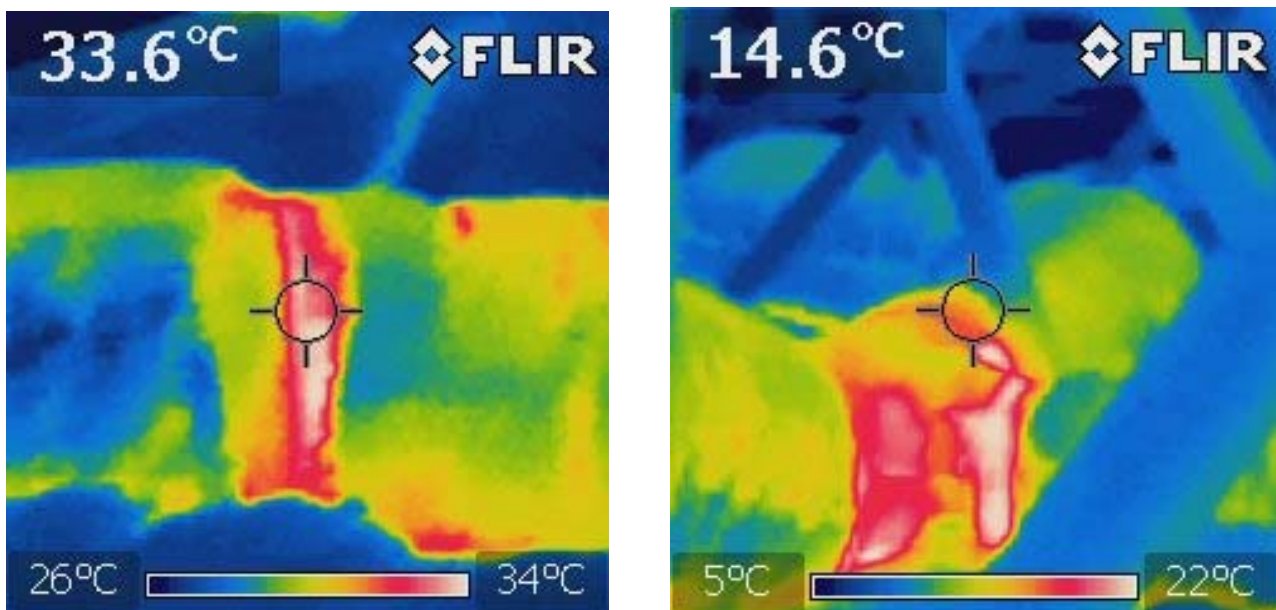
Figure 19 Thermal images showing heat loss around duct junctions

Thermal imaging of ductwork was undertaken and this was effective in determining gaps in the insulation cover and also demonstrated significant heat loss around duct junctions which often had little if any insulation coverage. Figure 19 shows examples of the thermal imaging of duct junctions and reveals that these points are often areas of significant heat loss.

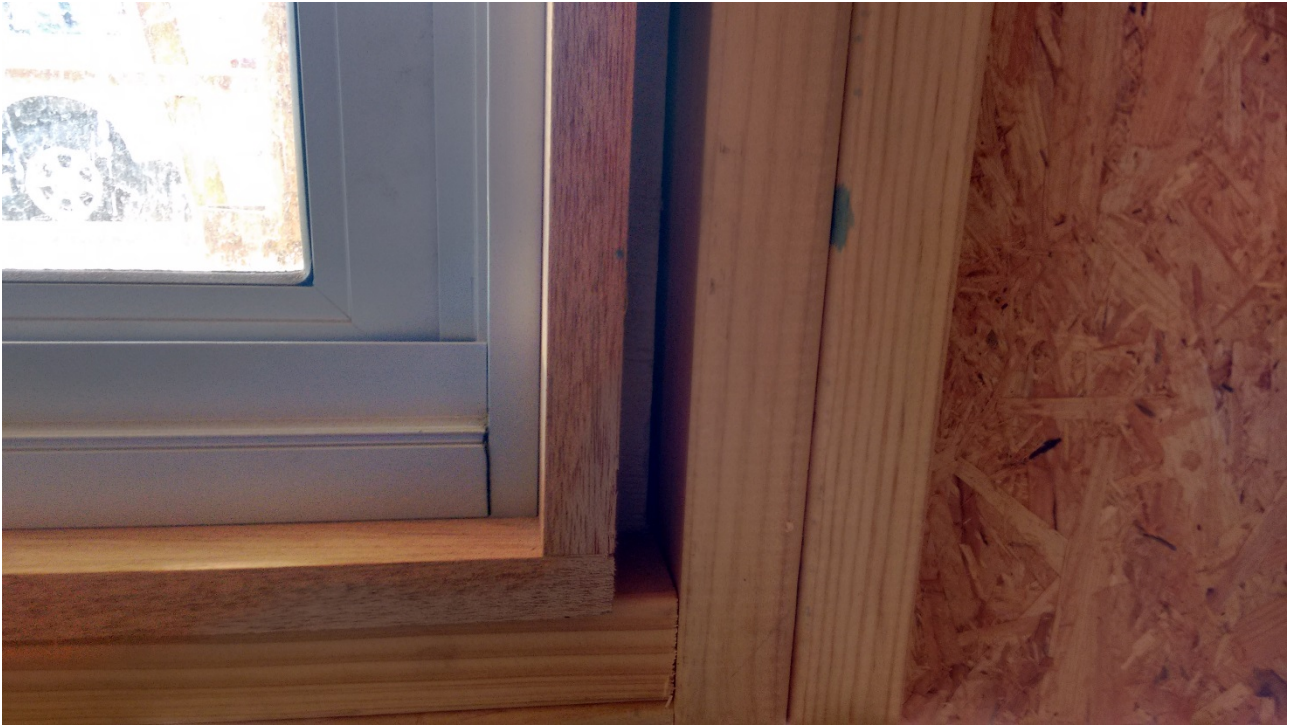
Figure 32 No sealing between window frame and house frame

may be worse than other parts of Australia. Wrapping building frames with insulation foil was uncommon in Adelaide and it was mentioned that some window suppliers believe Adelaide builders often don't seal the windows correctly. Inspection of window frame sealing on some of the buildings visited indicated that sealing was not done between the window frame and house frame (Figure 32) and instead the architrave is relied on to provide a barrier to the cavity. This is fairly common practice around Australia.

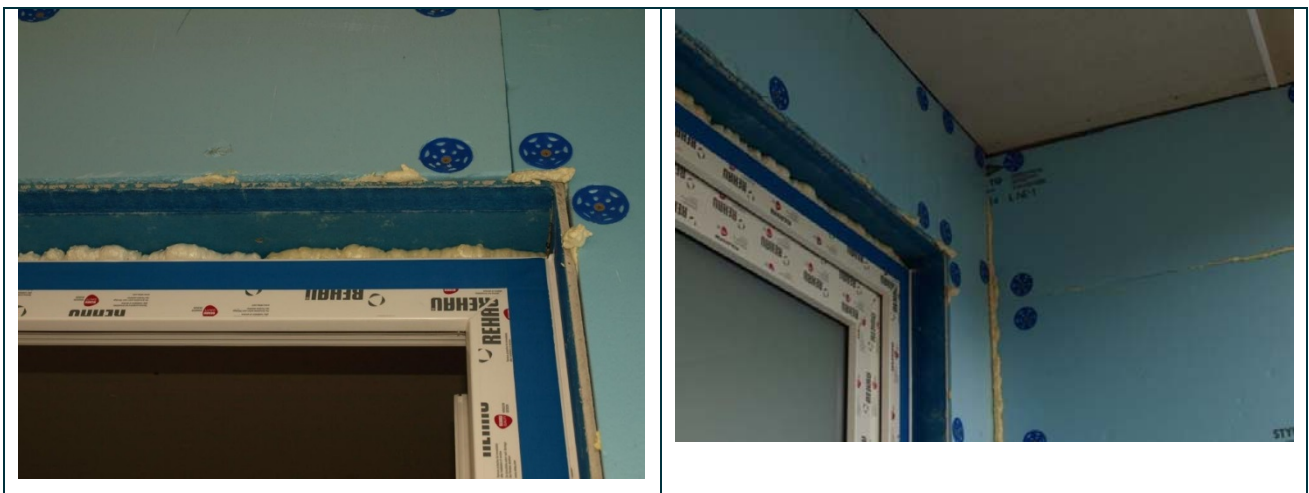
Figure 34 Example of good sealing of window frame to house frame

Figure 34 shows the sealing around one of the Adelaide houses that used uPVC window frames. In addition to the window frame's in-built sealing, additional sealing has been used in the form of expanding foam.

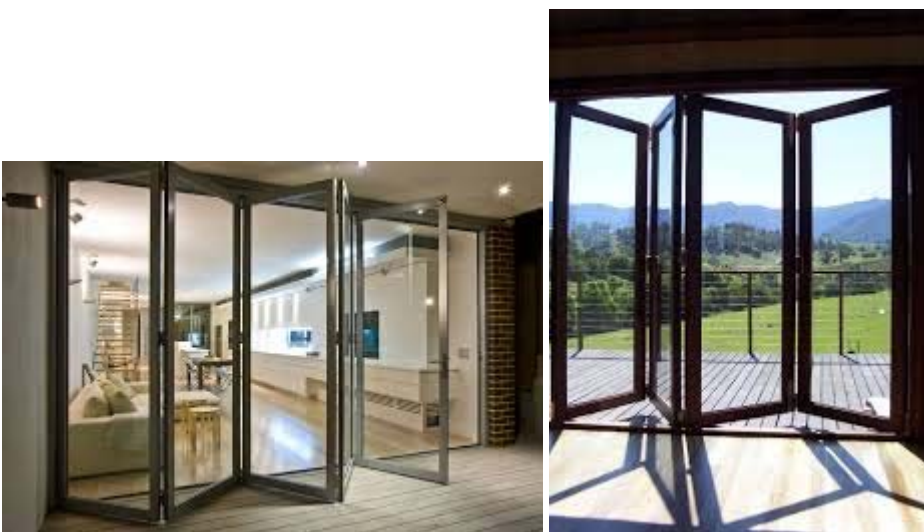
Figure 37 Examples of typical bi-fold doors showing the gaps between each door

It is interesting to note that one of the architects interviewed commented that one of their houses tested has French double doors that open to the outside and that providing a good seal to this style of doors is very difficult. Bi-fold doors (Figure 37) were also noted as being very difficult to properly seal between each door and that over time the seals that are provided in the gaps degrade and become ineffectual. Bi-fold doors have become increasingly popular in many new home designs and are often marketed as a luxury feature.
