House Energy Efficiency Inspections Project

Final Report

December 2015

A Report to the Department of Industry, Innovation and Science

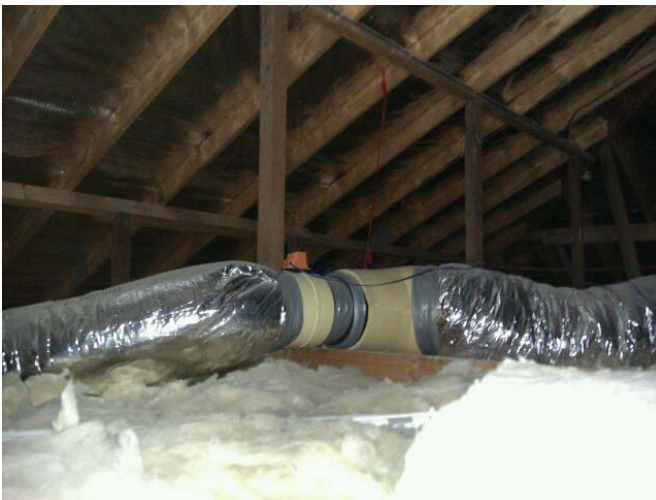
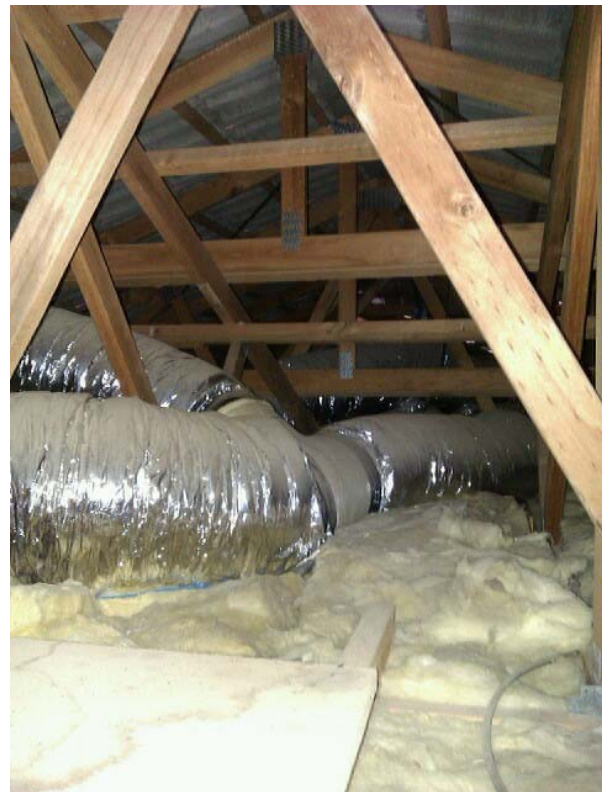
Figure 8 Typical ductwork inspection

Inspection of heating and cooling ductwork was more problematic than inspection of the ceiling insulation and weather sealing. Generally, the insulation level around the ductwork was unable to be determined unless it was physically printed on the ductwork itself. Thickness of ductwork insulation was also impossible to determine as this would have required dismantling of the ductwork. Visual inspection of ductwork was possible although limited to what could be viewed through the access hatch into the ceiling space. The Melbourne based houses did not have their ductwork inspected as these houses were inspected as part of the RBEES and ductwork was out of scope for that project.

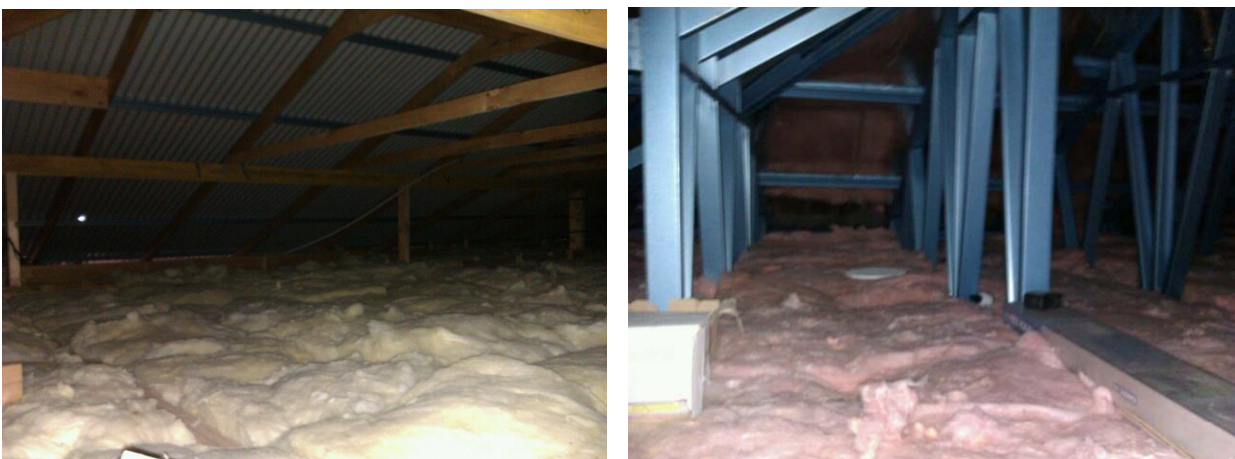
Figure 14 Examples of ceiling insulation rated as good

Figure 12 shows some examples of houses that had their ceiling insulation rated as poor. The image on the left shows batts moved to place pipework, but not replaced. The centre image has batts still in their packaging and not installed, while the right hand image shows gaps at the end of a batt that have not been filled. Figure 13 shows examples of ceiling insulation rated as average. The image on the left shows larger than required gaps around downlights, the centre image shows damage to the sarking and the image on the right shows inconsistent thickness of the insulation. Finally, Figure 14 shows examples of ceiling insulation as good with both images showing consistent, even and adequate thickness of coverage.

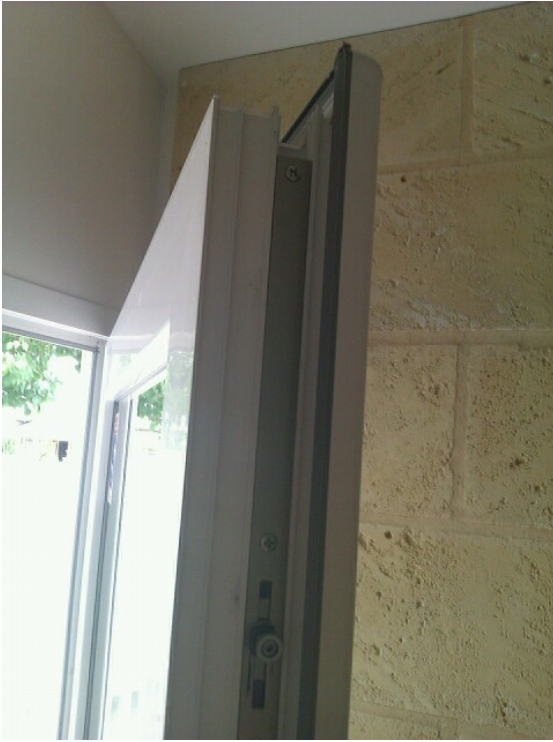
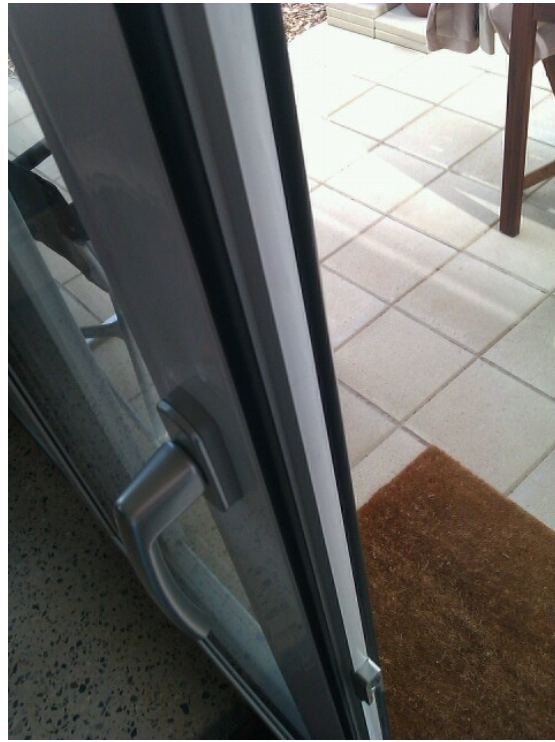
Figure 27 Examples of seals on uPVC windows and door frames

It is interesting to note that six of the houses tested used uPVC window frames. These frames usually have built in sealing systems to provide a tight seal between the window frame and the house frame. Figure 26 shows the air change rates for each house by their window frame type. Houses with aluminium or timber frames have a broad range of results while houses with uPVC window frames recorded much lower air change rates than most other houses. Figure 27 shows examples from two houses of the sealing system that is typical on uPVC window and door frames.

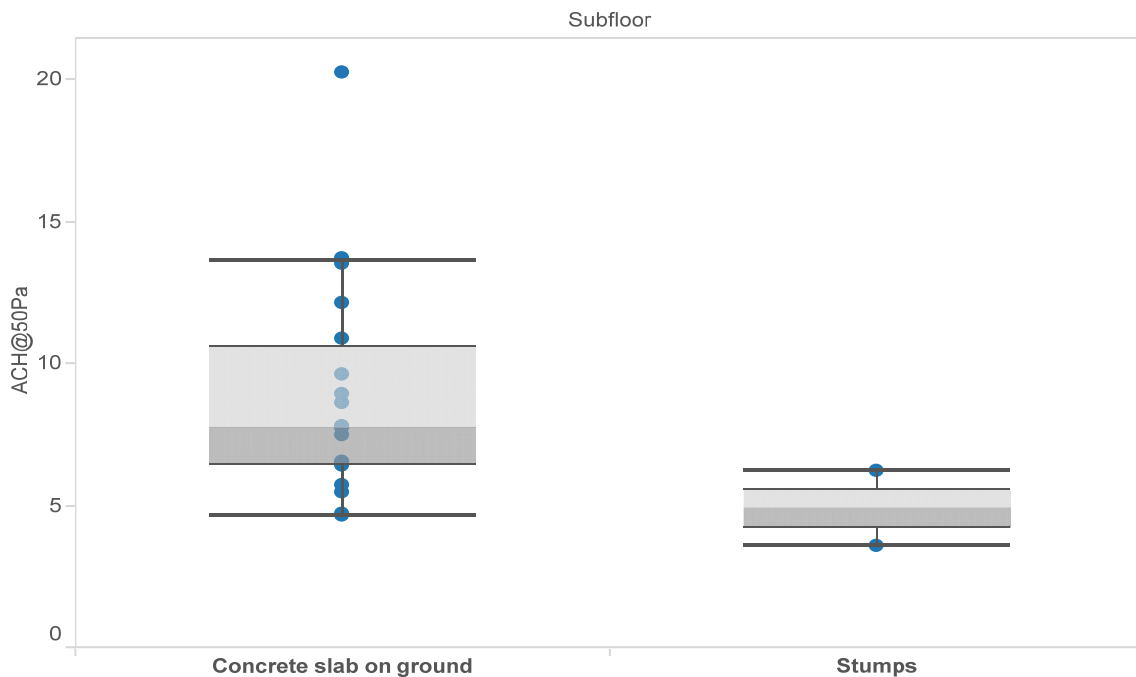
Figure 31 Adelaide houses air change rate by floor system

The floor systems used were also investigated and although the majority of houses tested were concrete slab on ground, it is interesting to note that two houses were on stumps and that these two houses actually had very good pressure results at around 5 ACH@50Pa (Figure 31). This result seems counterintuitive, but the houses used concrete panel floor systems which provide excellent sealing conditions.

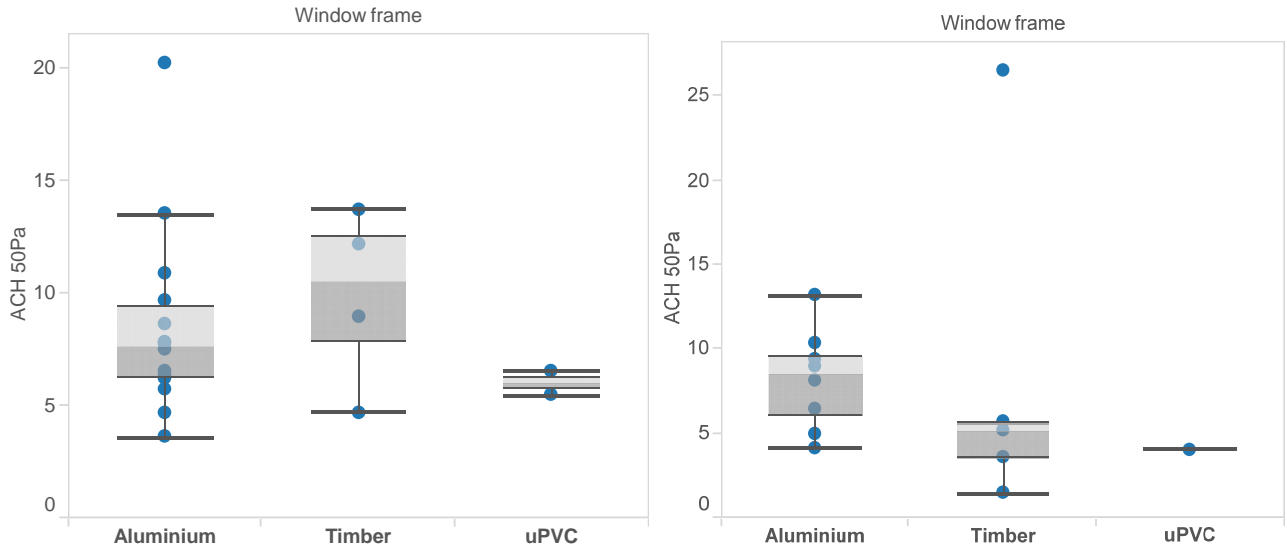
Figure 33 Adelaide (left) and Hobart (right) houses air change rate by window frame

As was mentioned earlier, houses using uPVC window frames were noted as having lower air change rates. Two of the architects interviewed in Adelaide also mentioned that many uPVC window systems have a built-in sealing system that provides for a tight seal between the window frame and house frame. Two of the houses in Adelaide and one in Hobart utilised uPVC window frames and all recorded low air change rates (5.4, 6.5 and 4.0 ACH@50Pa). Figure 33 compares the air change results by window frame type for the Adelaide and Hobart houses and the uPVC window houses perform well compared to the other frame types. It is also worth noting that the Hobart houses saw a very high use of double glazing. Overall, 95% of Hobart houses used double glazing which is significantly higher than any other city. Interestingly, Adelaide had the next highest usage at 40%. The high use of double glazing in Hobart is to be expected given the climate and the high number of custom/architect designed houses that were in the Hobart cohort. To achieve the 6 star NatHERS rating in Hobart many houses would need to utilise double glazing.

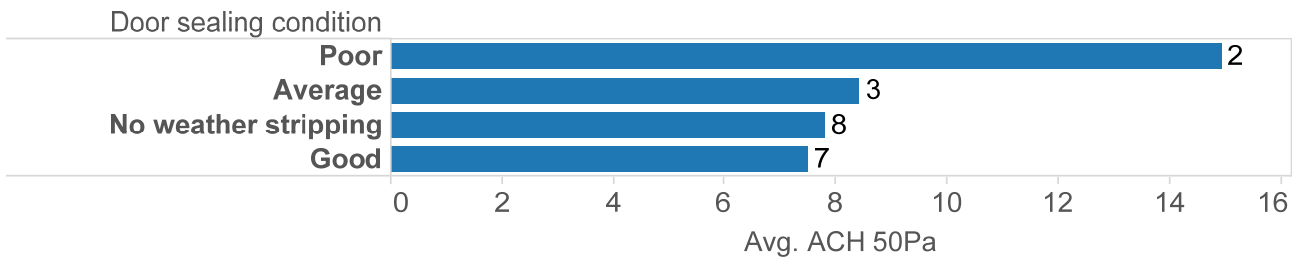
Figure 35 Adelaide houses air change rate by door sealing

Good sealing around doors also appeared to be a factor in helping houses achieve a good air change rate. Figure 35 shows the Adelaide house results of air change rates by the quality and condition of door seals and shows that houses with good seals performed significantly better than houses with average or poor levels of sealing. Figure 36 shows the Hobart house results and also shows that houses with door seals in better condition did generally perform better.
